LOWER DAM
NH 00129
NHWRB 222.01

PHASE I INSPECTION REPORT
NATIONAL DAM INSPECTION PROGRAM

DEPARTMENT OF THE ARMY
NEW ENGLAND DIVISION, CORPS OF ENGINEERS
WALTHAM, MASS. 02154

AUGUST 1980

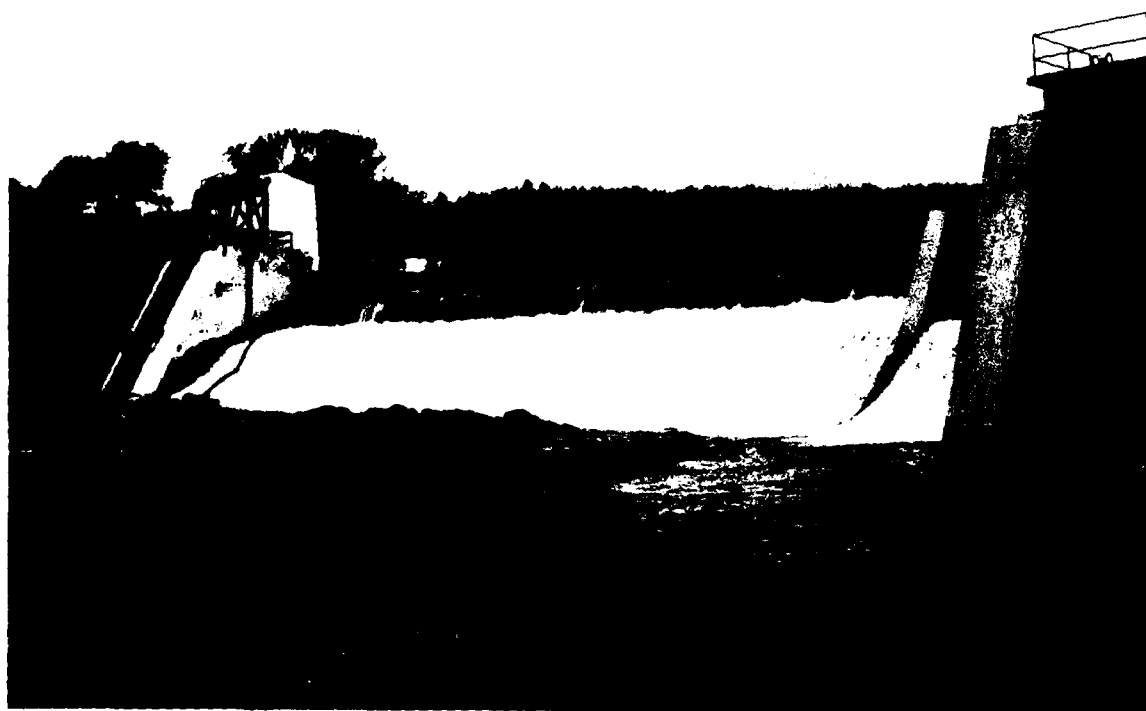
Overview of Dam

The dam and its appurtenant structures are generally in good condition. The only problem areas noted during the visual inspection were the spalled concrete on the head gate structure and the right abutment, and the non-failing type flashboards.

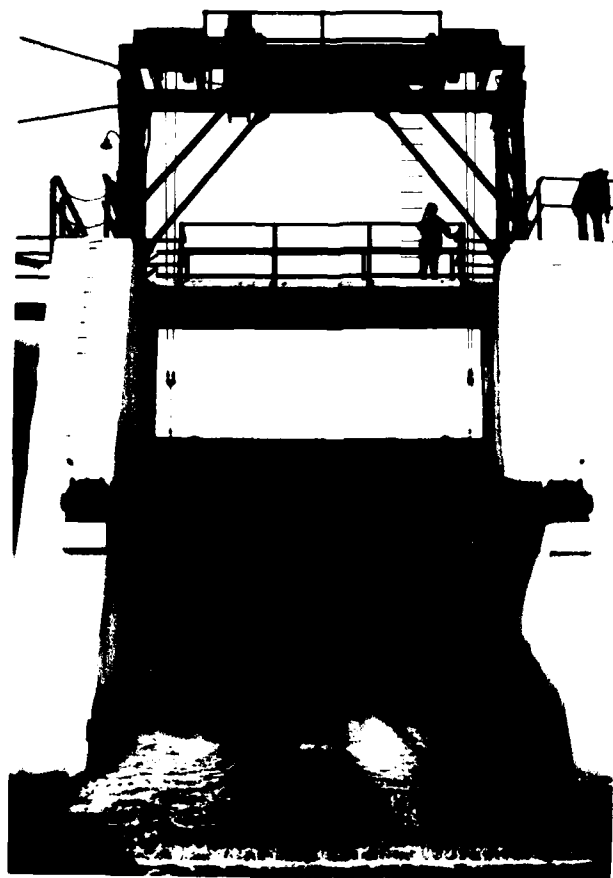
The Tainter gate was opened about 1 foot through the operation of the electrical controls contained in the gate control box and remained in this position for about 15 minutes. The opening was limited to this height to reduce downstream problems. It was obvious the gate is very effective in that the upstream pond level lowered very quickly. At the end of this test the gate was closed. The structural steel supports are in good condition.

8. View of tainter gate from downstream

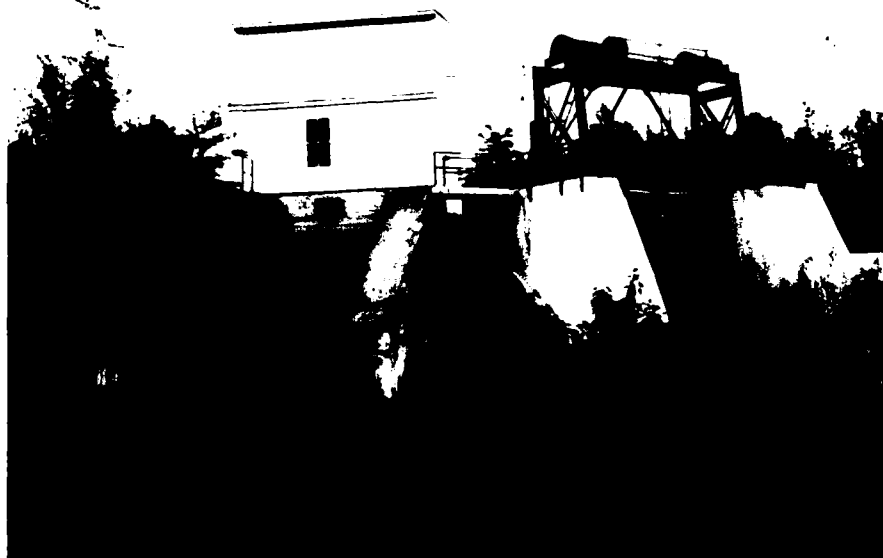
5. View of gate house from downstream side

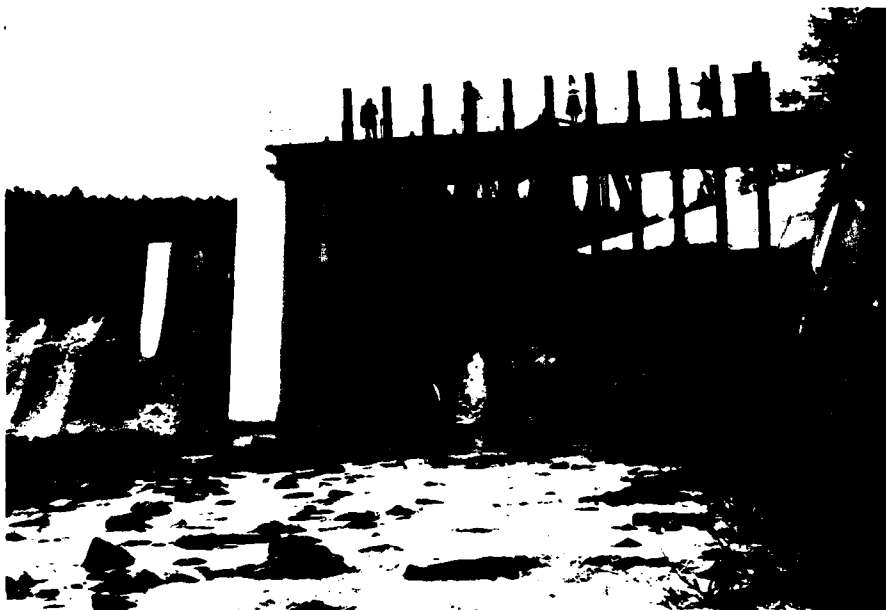
This structure consists of 12 openings with intermediate 12" x 12" retractable column stanchions. Stoplog slots are cast into the left end wall and the left side of the pulp gate buttress. The stanchions have been subjected to minor surface rust below the stoplog crest elevation. The 6-inch stoplogs are in fair condition, however, seepage through the adjacent logs is in the range of 200 g.p.m. A representative of the owner indicated that the stoplogs are scheduled for replacement during the summer of 1980.

2. View of stanchion section and pulp gate

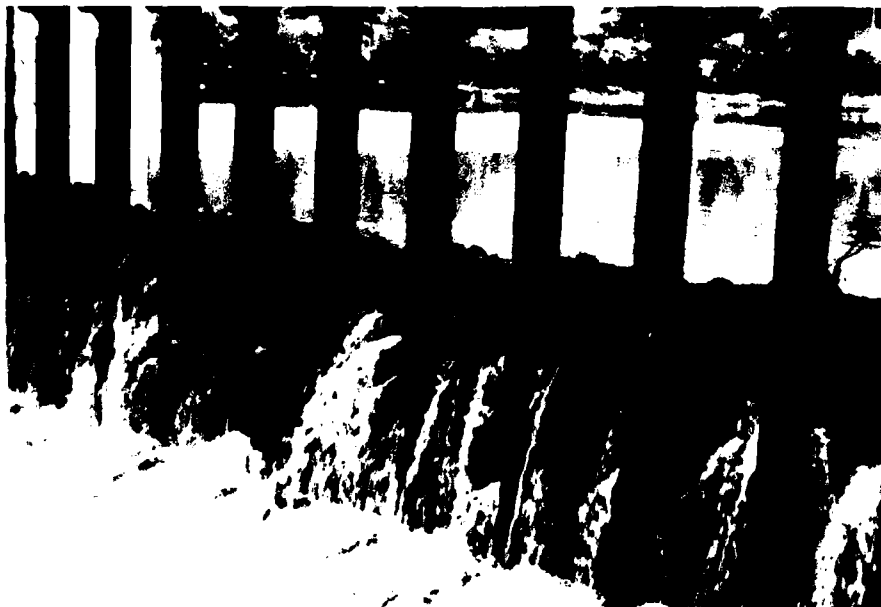
3. Stoplogs in stanchion section
note metal strap on removeable stoplogs

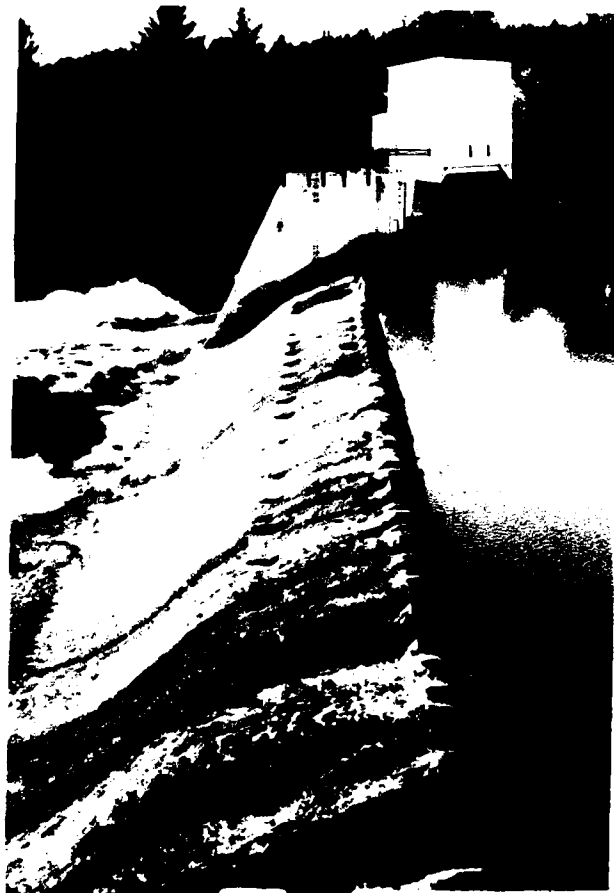
This structure is a concrete ogee spillway equipped with flashboards. The flashboards consist of fabricated wood panels 60 inches long and 42 inches high and 1 inch roughsawn stock. The 2 inch stanchions are located approximately 18 inches on centers and are socketed into the concrete for a depth of 7 inches. The flashboards and stanchions are in good condition. A reserve supply of flashboards and stanchions is available in a storehouse located on the right bank. These flashboards are of the non-failing type and may effect the stability of the dam.

1. View of spillway from left side
